RE: Request for an AJD for the wetlands on five parcels in the ownership of:

Parcels of Town of Montgomery, Orange County, NY:
Section 29, Block 1, Lots 5.1, 5.2, 5.3, 5.4, 5.5 (5 lots)

The owner has described the proposed project (Sheffield Gardens) as the development of the five-parcel property with a combination of residential (single-family and multi-family units) and commercial entities. The final proposed limits of the project review area would be smaller than the parcel size and will be determined subsequent to the jurisdictional review of the USACE which is being requested by this current application. The items that are submitted here to assist you in your evaluation of this property are:

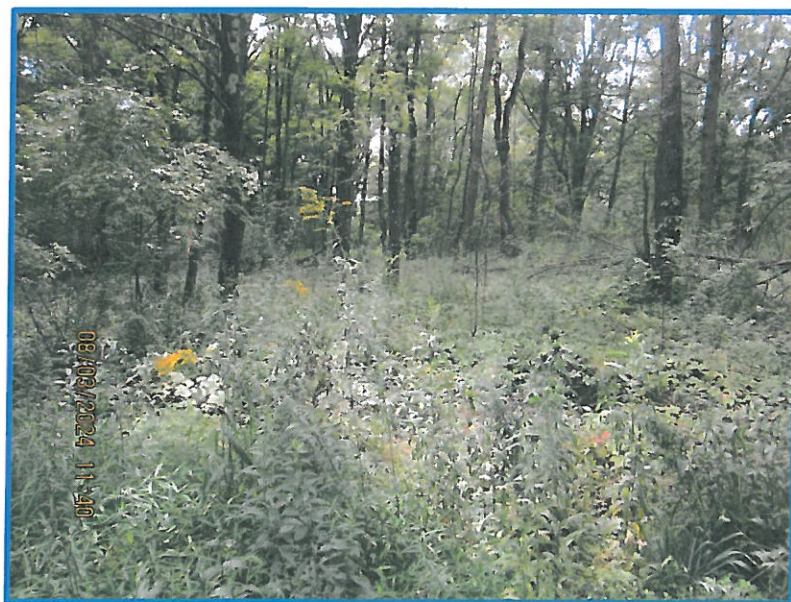
The upland areas of the property consist of a mature second-growth forest dominated by oaks and maples (FIGURE 1 - PHOTO 1). This covers approximately 48 acres of the 53-acre site. The dominant trees are pin oak, red oak, sugar maple, red maple, ash, and American beech. Under the fully closed forest canopy provided by these trees, the understory was noted to be densely vegetated with privet shrubbery. The shrub layer did include other areas where Japanese barberry, multiflora rose, Allegheny blackberry, and bush honeysuckles were dominant. Japanese honeysuckle was also observed, infrequently, throughout both the forested and shrubby areas of the site. The seasonal herbaceous layer of vegetation was largely characterized by the presence of the invasive non-native herb, garlic mustard. Areas of copse forming trees, including sumacs, tree-of-heaven, and black locust, are present along the northern and western forest edges of the property.

PHOTO 1 – Oak-maple hardwood forest upland

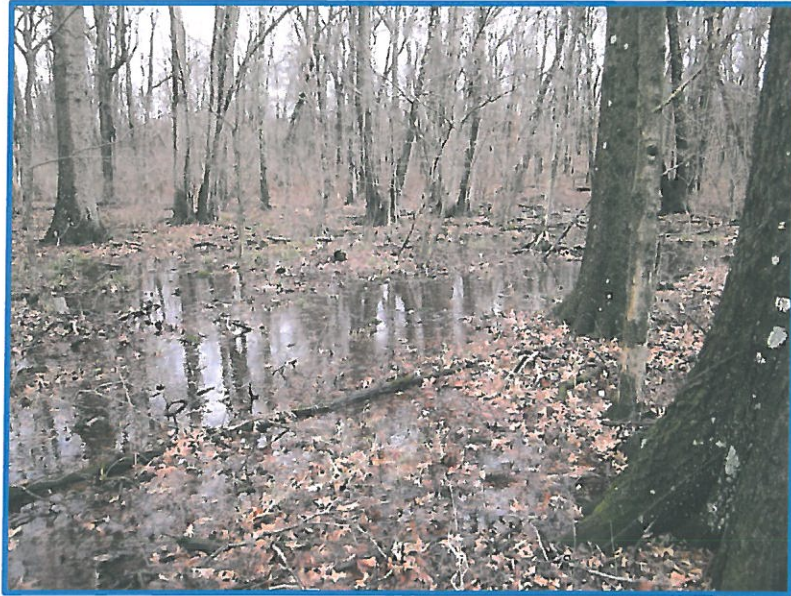
The forested wetland areas of Wetlands A and C (FIGURE 1 – PHOTOS 2 and 3) were dominated by stands of pin oak, American elm, and red maple in areas of either sparsely or densely developed undergrowth. Where the understory was significantly vegetated, the predominant forms of shrubby undergrowth were silky dogwood, winterberry, nannyberry, and multiflora rose. Herbaceous species included wood reed grass, stiltgrass, sensitive fern, and melic mannagrass.

PHOTO 2 – Palustrine forest at Wetland A.

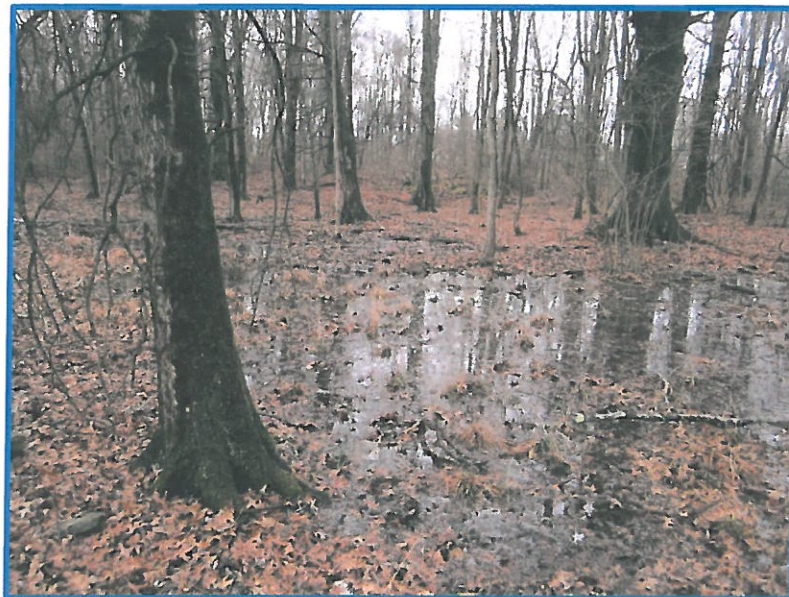
PHOTO 3 – Palustrine forest at Wetland C.

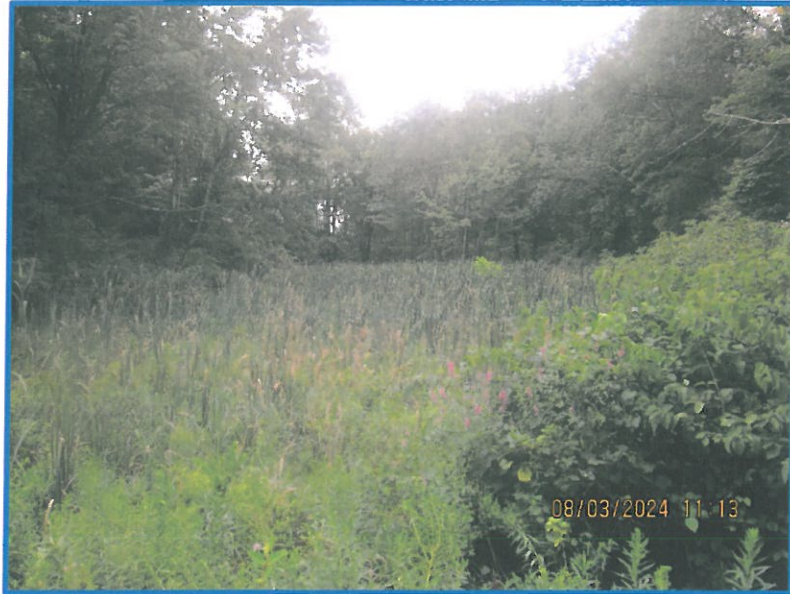
This habitat is present within portions of both Wetlands C and D (FIGURE 1 – PHOTOS 4 and 5). Wetland C has a community of emergent vegetation that is primarily present within a shallow depression colonized by cattails, sensitive fern, purple loosestrife, and common reed (phragmites). The emergent community associated with Wetland D is present as a broad area of vegetation that surrounds the open water portion of NYSDEC Wetland WD-29. The dominant plants present are broadleaf cattails, false nettle, jewelweed, and dotted smartweed.

PHOTO 4 – Emergent Vegetation at Wetland C.

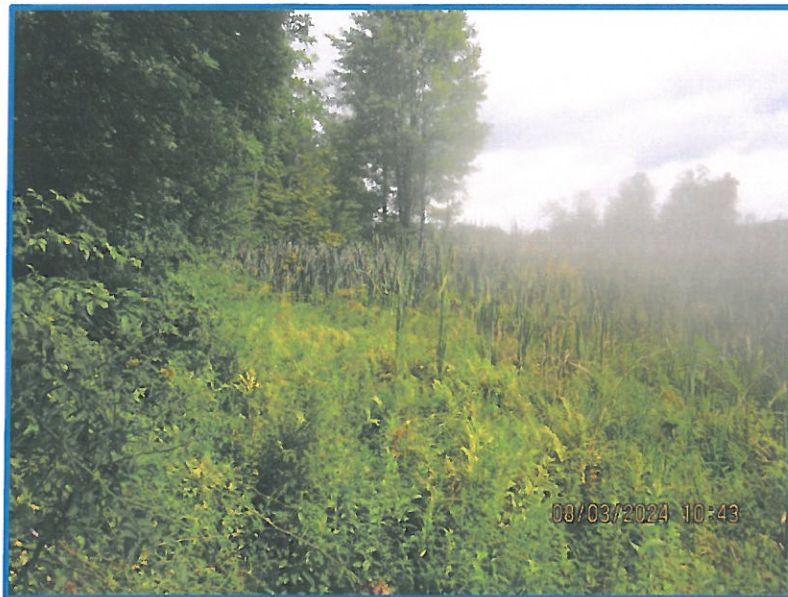
PHOTO 5 – Emergent Vegetation at Wetland D.

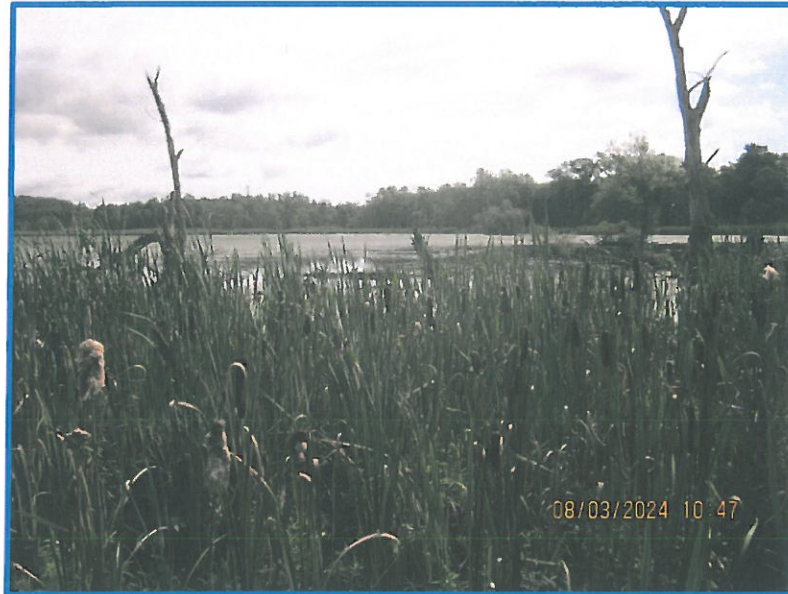
The open water portion of NYSDEC Wetland WD-29 (FIGURE 1 – PHOTO 6) is a very shallow area of reverted, previously ditched and drained marshland that is flooded in most years. Presently this area includes an expanded area of shallow, open water that forms a nutrient-rich, eutrophic pond. This area is shown as open upland fields on USGS maps as recently as 1957, and is shown with only limited areas of open water by GOOGLE EARTH imagery as recently as 2006. Sampling of the floating or rooted vegetation in this open water portion of Wetland D was not feasible during this investigation.

PHOTO 6 – Eutrophic Pond at Wetland D.

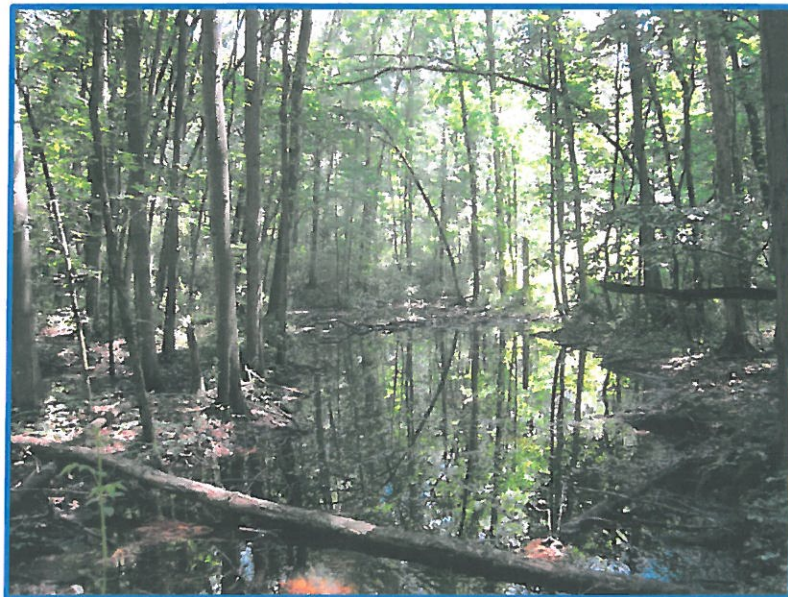
The several small forested wetland areas mapped in the southwestern portion of the Project site (FIGURE 1 – PHOTO 7) included areas that had extended periods of flooding and that were observed to be utilized by wood frogs for breeding during spring of 2023. Vegetation around these pools included red maple, elms, sycamore, silky dogwood, and multiflora rose. Seasonal observations of the confines of the pool showed it to be either unvegetated when flooded in wet seasons, or very sparsely vegetated during dry season visits to the site.

PHOTO 7 - Vernal pool at Wetland B.

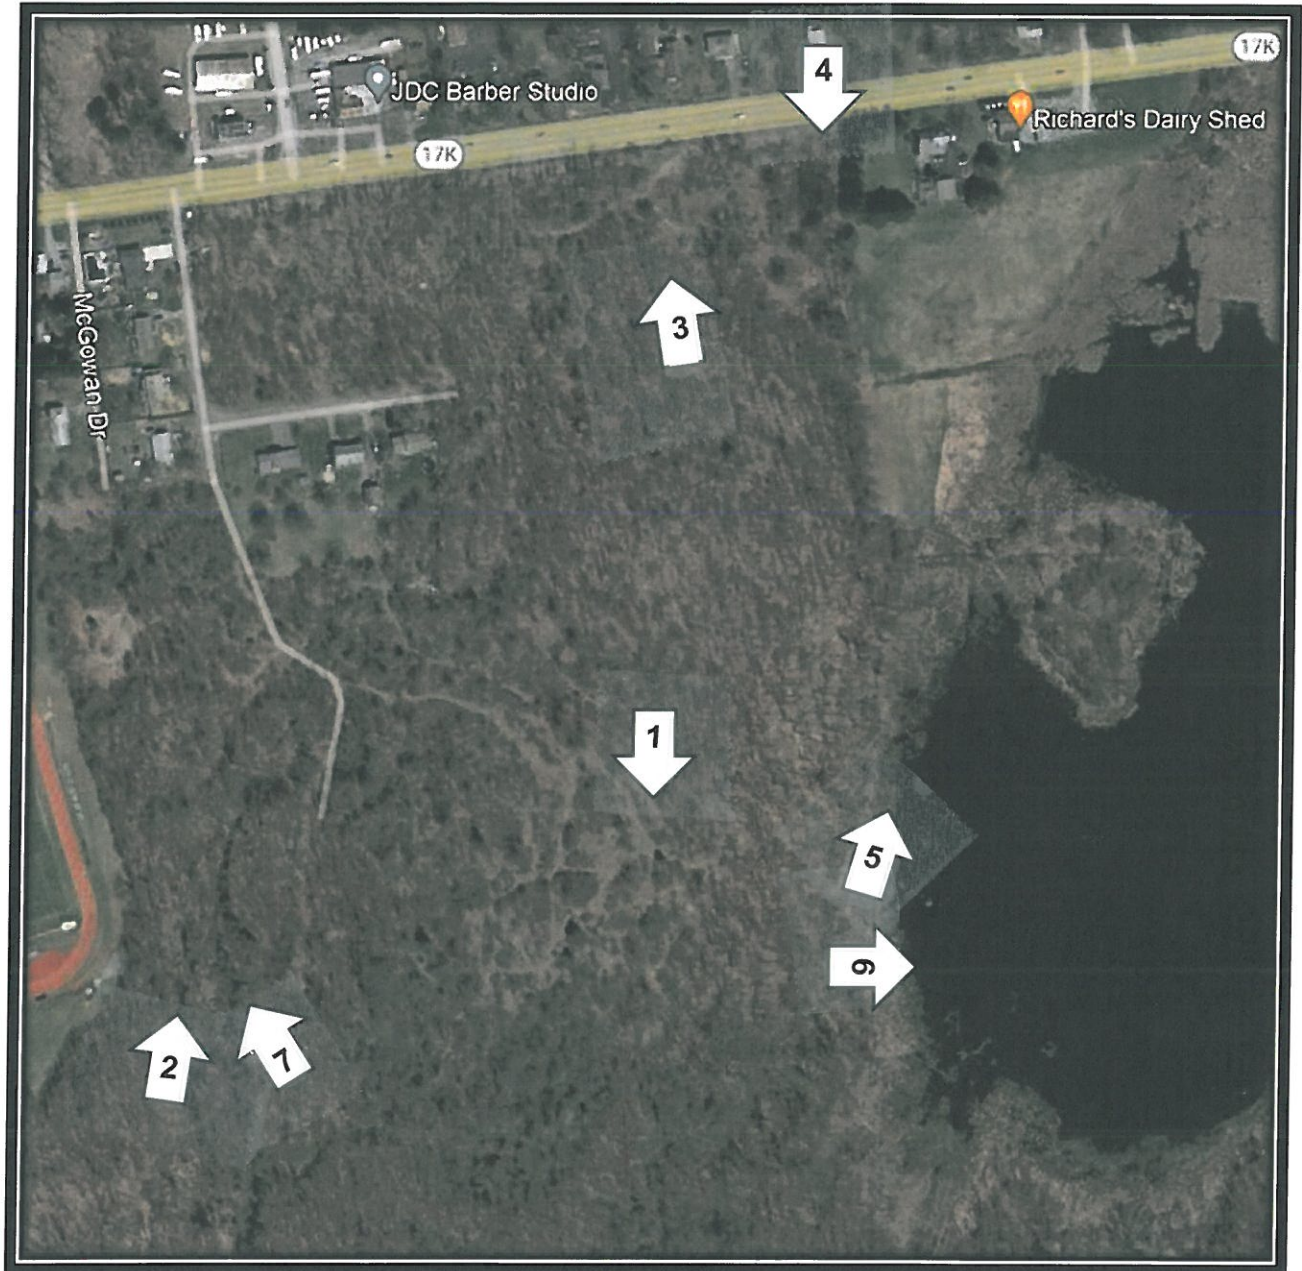
Figure 1 - Photograph locations

1. Upland – Oak-maple hardwood forest
2. Wetland – Palustrine forest
3. Wetland – Emergent vegetation meadow
4. Wetland – Eutrophic pond
5. Wetland – Vernal pool

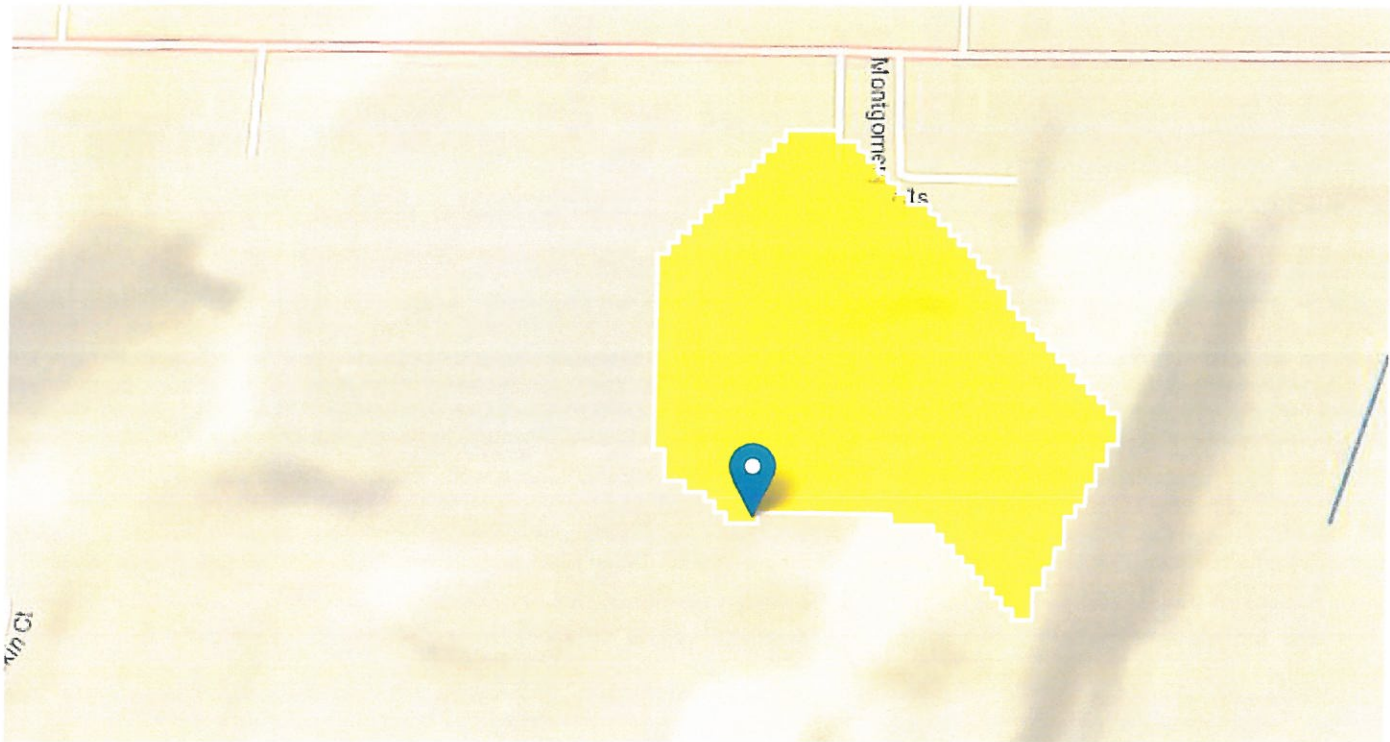
StreamStats Report for southwest drainage from Wetland "A"

Parameter Code	Parameter Description	Value	Unit
DRNAREA	Area that drains to a point on a stream	0.049	square miles
LC11DEV	Percentage of developed (urban) land from NLCD 2011 classes 21-24	34	percent
LC11IMP	Average percentage of impervious area determined from NLCD 2011 impervious dataset	6.89	percent
OUTLETX	Basin outlet horizontal (x) location in state plane coordinates	565505	feet
OUTLETY	Basin outlet vertical (y) location in state plane coordinates	4596965	feet
PRECIP	Mean Annual Precipitation	39	inches

A second stream flows to the southwest and west as a Stream Order 1, non-RPW. The attached USGS StreamStats reporting⁴ assigns a drainage area size of 0.049 square miles to Wetlands A and B, from the point of discharge from Wetland A. This stream, with an unconsolidated sandy/gravel bottom, flows generally westward for approximately 1.64 miles before entering the Wallkill River, a straight (aerial) distance of approximately 0.85 miles.
