SOIL TESTING LOCATIONS

SHEFFIELD GARDENS
NYS ROUTE 17K
TOWN OF MONTGOMERY
ORANGE COUNTY, NEW YORK

DEEP TEST PIT SOIL RESULTS

PROJECT TITLE
Sheffield Gardens

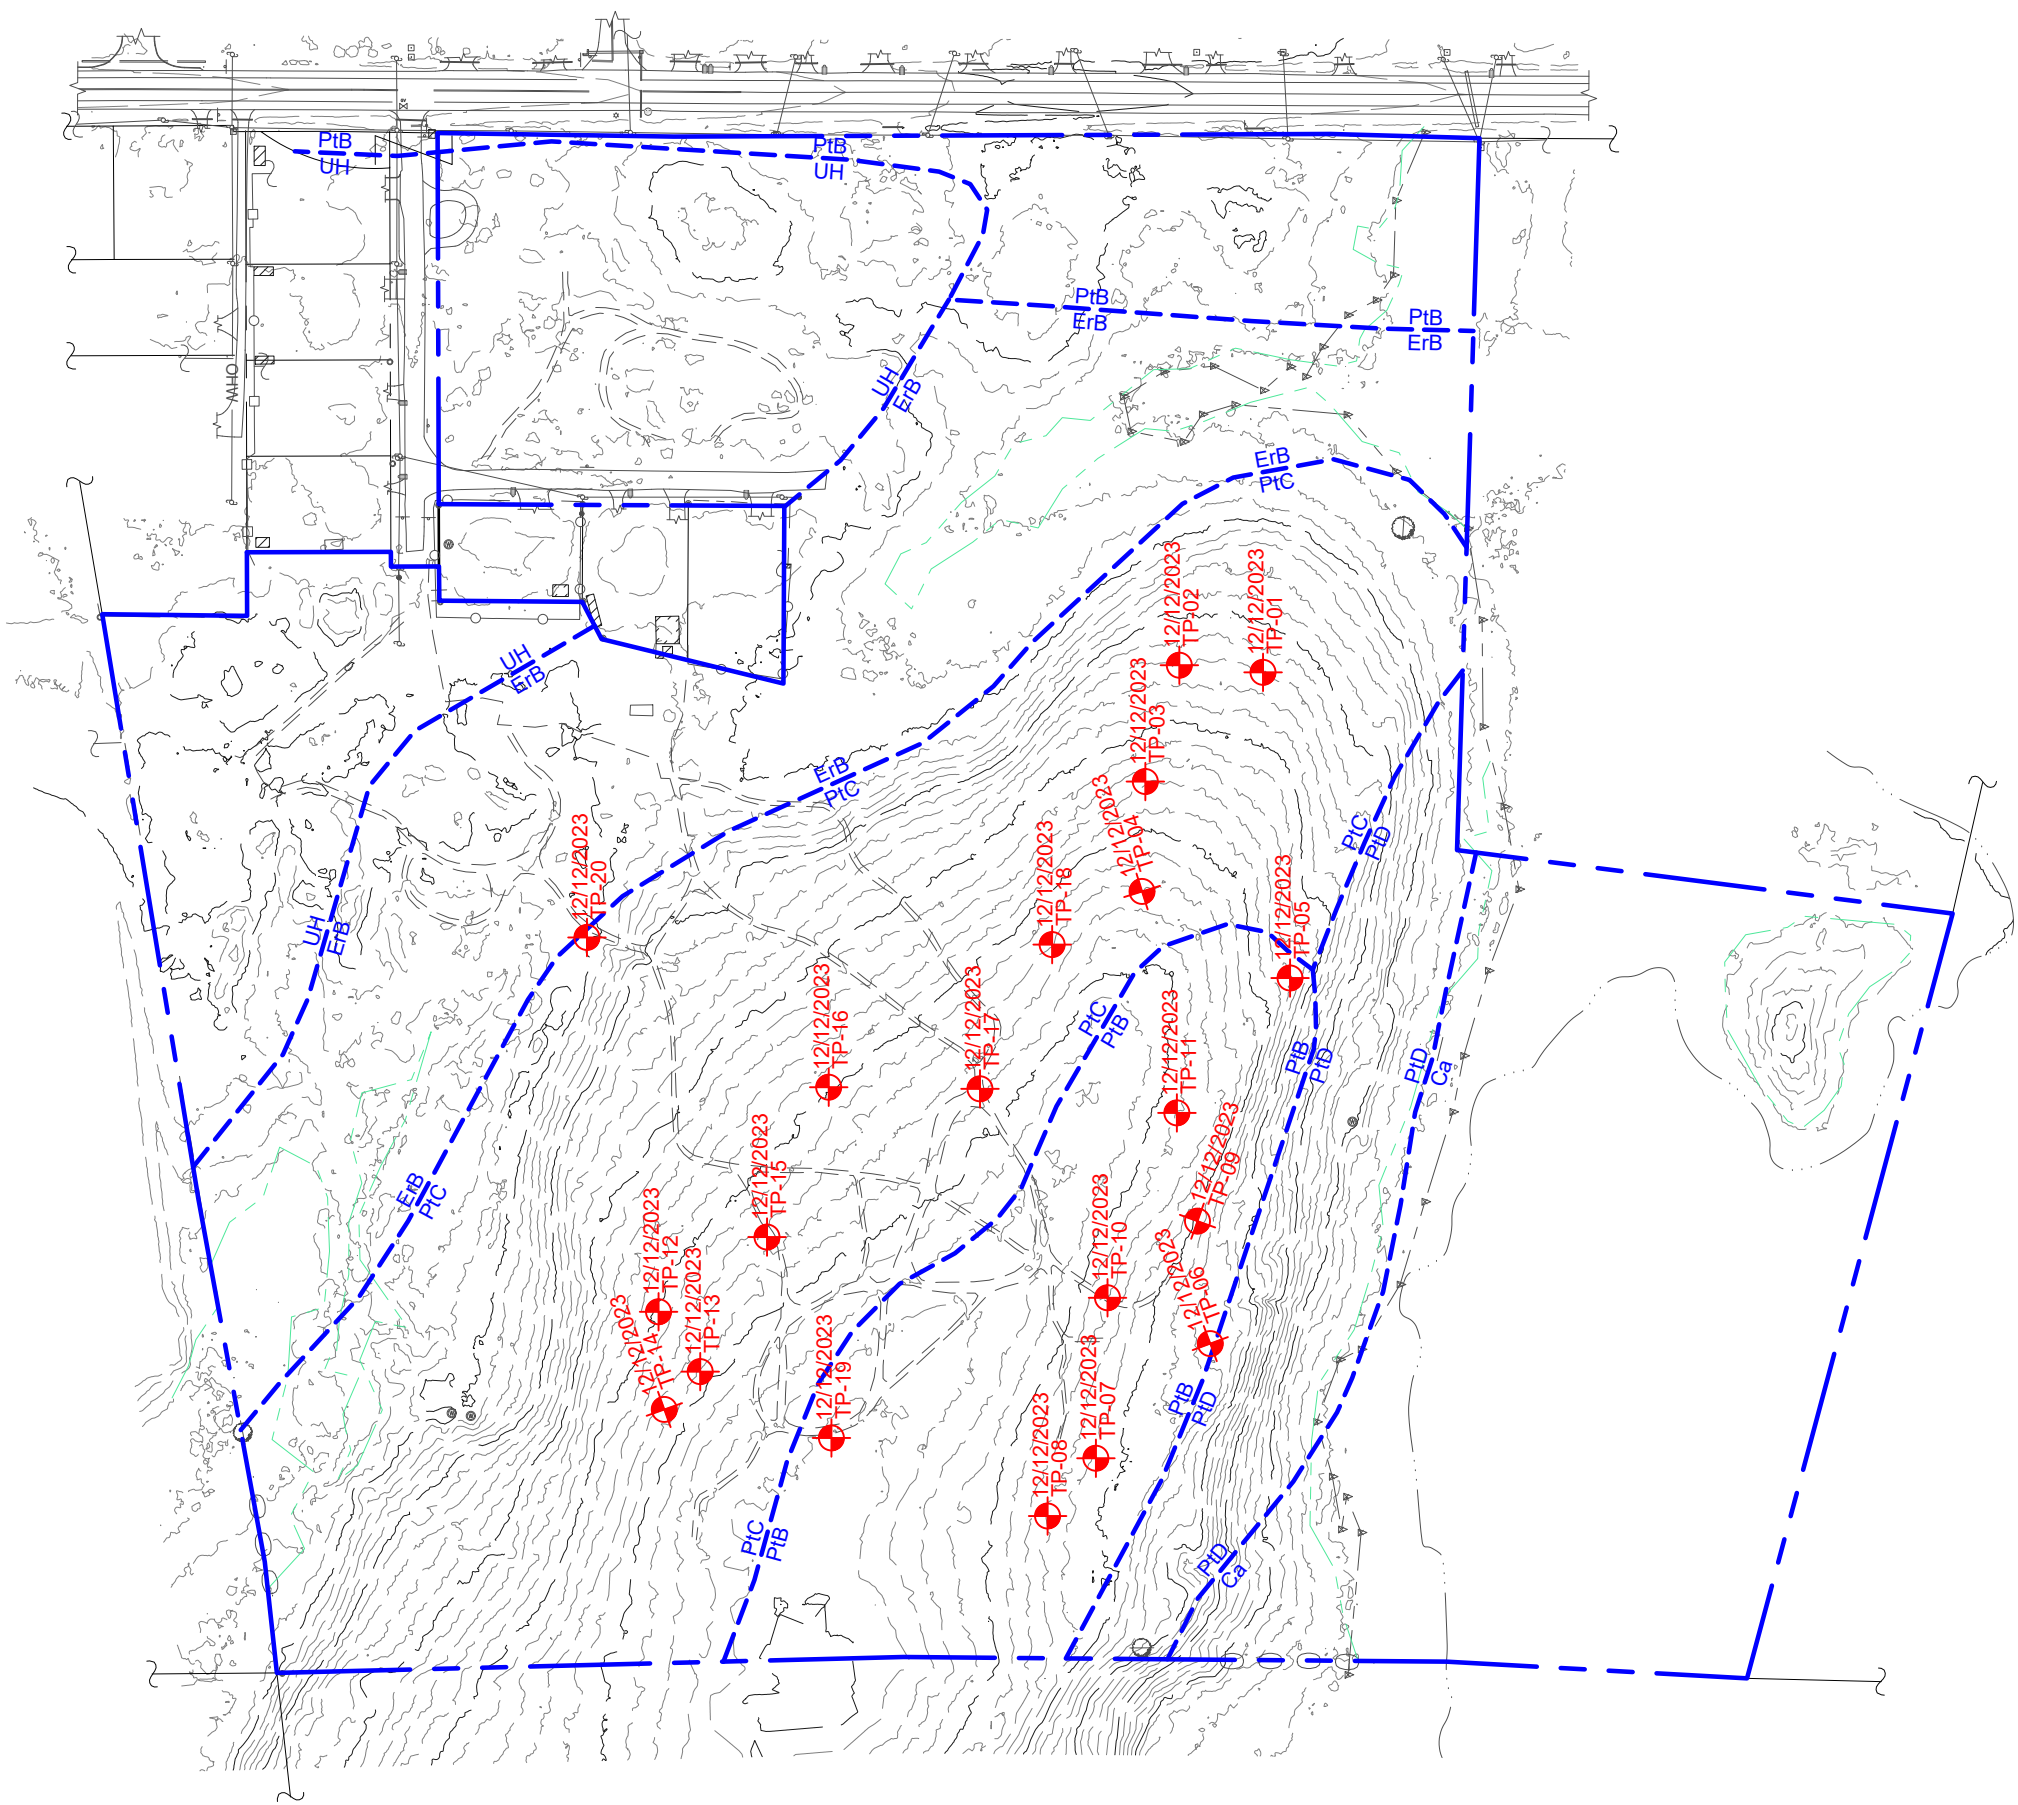
JOB # 103.0301
SHEET # GT-1

SOIL TYPE	DEPTH TO BEDROCK	DEPTH TO WATER TABLE	EROSION FACTOR Kf	EROSION FACTOR Kw	PERCENT CLAY
Ca CANANDAIGUA SILT LOAM	>200 CM	0 IN	0.49	0.49	22.2%
ErB ERIE GRAVELLY SILT LOAM, 3 TO 8 PERCENT SLOPES	>200 CM	6 - 18 IN	0.32	0.20	22.0%
PiB PITTSFIELD GRAVELLY LOAM, 3 TO 8 PERCENT SLOPES	>200 CM	> 80 IN	0.28	0.17	11.4%
PnC PITTSFIELD GRAVELLY LOAM, 8 TO 15 PERCENT SLOPES	>200 CM	> 80 IN	0.28	0.17	11.3%
PnD PITTSFIELD GRAVELLY LOAM, 15 TO 25 PERCENT SLOPES	>200 CM	> 80 IN	0.28	0.17	11.2%
UH UDORTHERTS, SMOOTHED	>200 CM	36 - 72 IN	0.24	0.15	10.6%
